Product Technical Update

Equinox Front & Rear Monitors

Equinox touch screen new PN # 910T0043-505

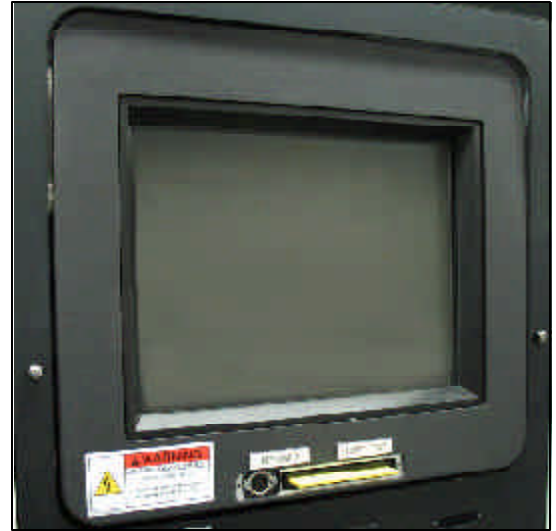
The new front monitor is an ELO flat panel display. (See photo at right). There is no longer a powercard contained within the monitor so a UPS (uninterrupted power supply) must also be installed. This will allow the monitor to continue operating in the event of power loss to the tool. All stored settings and teach points will be retained. The software and wiring changes to the front monitor require that the rear monitor be replaced as well. *(The old monitor will not work with the software changes).* Additionally, if the power supply on the rear monitor is not **PN # 73147-56** it will have to be replaced during this upgrade.

Equinox touch screen monitor

Equinox tools were built with touch screen monitors. The front monitor contained a 486 Pentium as the main computer. The 486 is no longer supported by the manufacturer and will be replaced with Pentium III computers. This upgrade necessitates new software and wiring changes.
